The restoration of an early 17th century chest

Jonny W. Stadler, Lindengasse 1, D-6900 Heidelberg, West Germany. (Reproduced in translation from „Arbeitsblätter für Restauratoren“ 20 (2) (1987), pp 34–41 with the permission of the editors.)

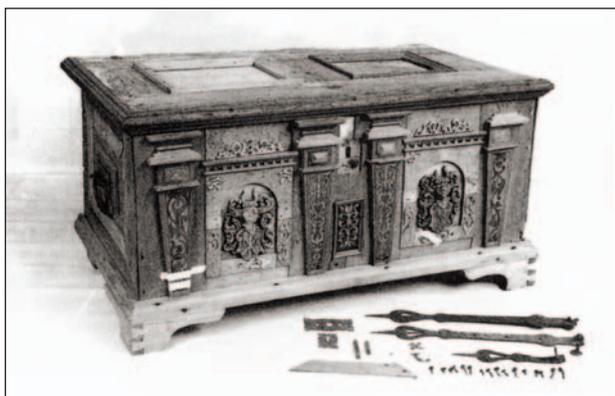
The object was discovered by its present owner under a pile of firewood in a village in the Harz. He purchased it and had the white paint stripped off. In this condition the chest was brought for conservation (Fig. 1).

Fig. 1 Chest before restoration

The base and the left lid panel are modern replacements; the body is so deformed that the sides are no longer vertical nor square to each other. The back has several cracks along the grain. Most of the joints are open and the applied ornament loose. Parts of the strapwork of the arcades are missing entirely. A photograph taken by the owner prior to stripping showed that the arches had contained keystones. Mouldings are probably also missing from the pilasters. Under the edges of veneers next to exposed carcass timber, which appeared grey, remnants of water soluble black paint were found. Large sections of the object, especially the base, lid and back are heavily wor-

meaten (*Anobia Punctatum*). Similarly, the coat of arms could be crushed by light pressure. The lid is very worn and damaged. The right edge moulding of the lid is missing. The object contains about 70 modern iron nails which have also split the wood in many places. Incorrect caustic stripping has bleached the oak and left traces of salt crystals. Also further very obvious destruction of the surface done by the stripper, who stapled the loose veneer back on after underlaying it with coarse sandpaper. The metal parts are corroded, the hinges are bent and broken apart at the knuckles. The lock, key and one handle are missing. Most of the wrought nails holding the ironwork are also missing or heavily corroded.

The lid is to be dismantled and cleaned. To strengthen it, the wood will be preheated and coated four times with a very thin animal glue, mixed with a fungicide and alum. To assist deep penetration, the object is to be brushed with ethyl alcohol. Missing sections are to be replaced with old, naturally patinated wood of matching structure. Due to shrinkage, the frame members of the lid no longer fit together: the tongues are longer than the crossmembers are wide so will be slight-

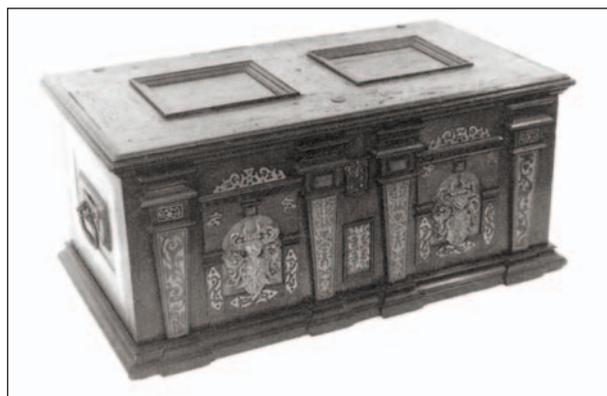
In comparison, a separate base frame was built, that the chest could be set upon (Fig. 2).

Fig. 2 Chest after restoration

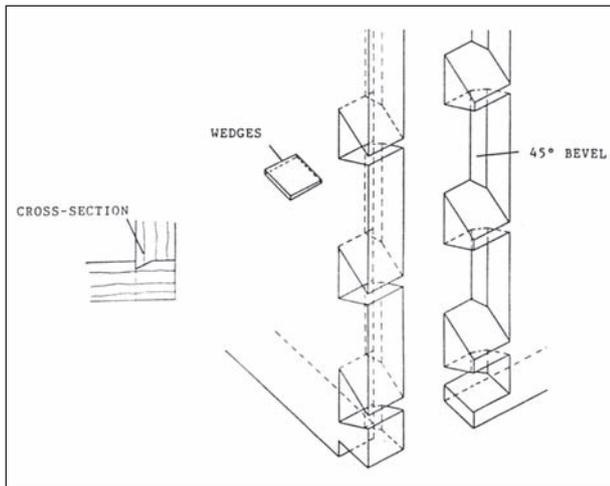
Solid boards dove-tailed at the corners, the bottom nailed to the sides. The dove-tails themselves are on the front and back, the uppermost cut to a mitre. The joint includes a kind of bevelled housing. Wedges 2–3 mm thick are driven into the pins (Fig. 3). A box with two small drawers at the base and a moulded lid is grooved into the left side.

Fig. 3 Dove-Tailed joint

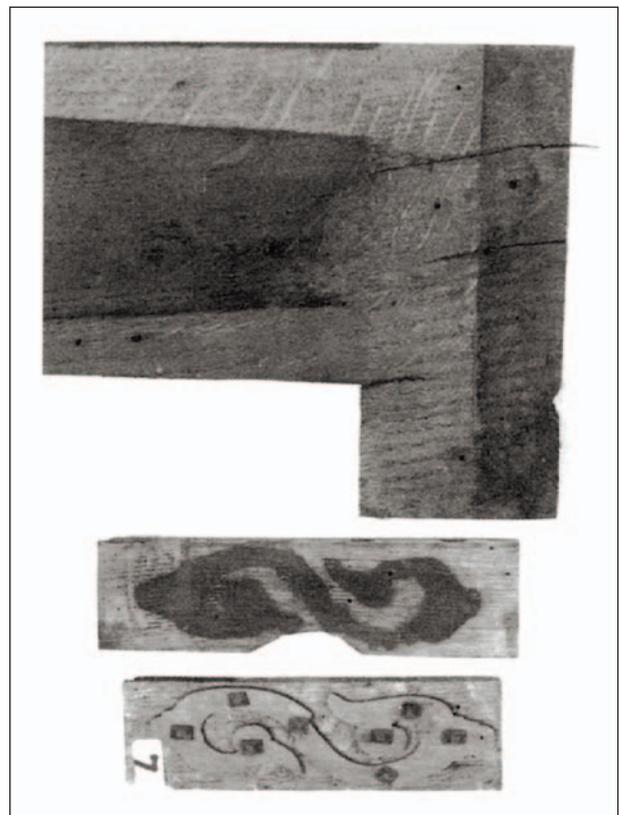
Fig. 4 Parts protected from the stripping under ornament and pilaster show the retained patina of the 400 year old oak
